RCRA Inspection Report

Benjamin Moore and Company
109 Bamberg Drive
Pell City, Alabama 35125
St. Clair County
EPA ID: ALD981472798

June 26, 2019 at 10:00 a.m. CDT

COMPLIANCE EVALUATION INSPECTION PHOTOGRAPHS

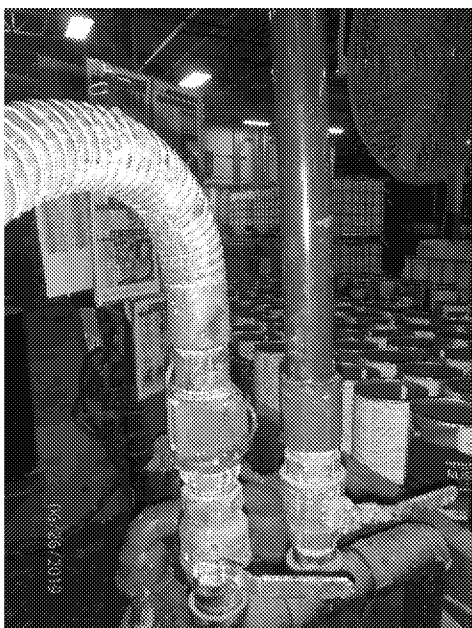
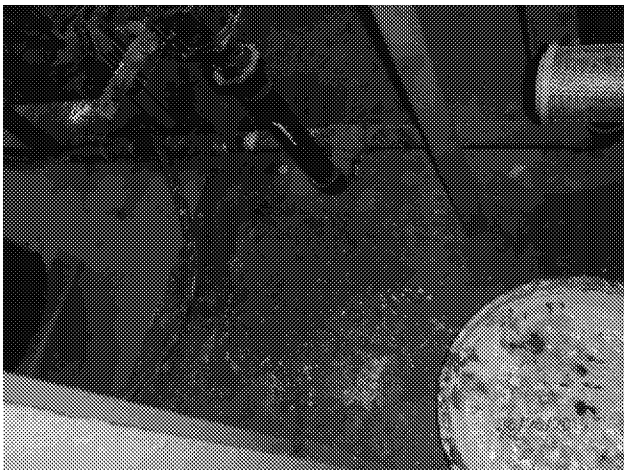
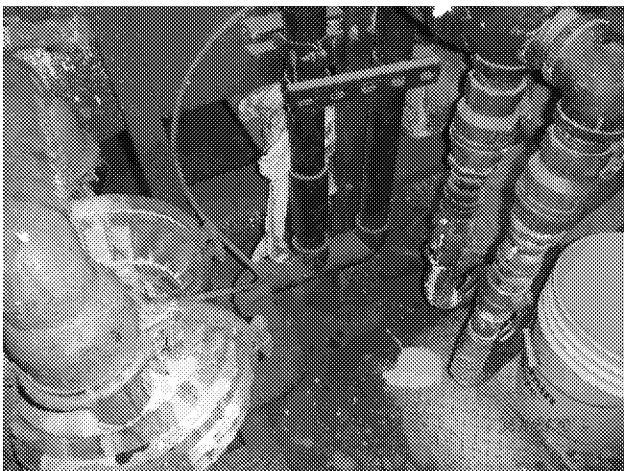
The inspectors observed that the Filling Line had four 55-gallon drums staged to capture the Alkyd fill tank flush (Picture 4). The dirty solvent flush lines were not marked (Pictures 1-3), but the lines are not currently connected to the hazardous waste tank which has been taken out of commission. Instead the dirty solvent is being piped in the 55-gallon drums. The drums were empty at the time of the inspection.

Picture 1 – Filling Line dirty solvent piping

Picture 2 – Filling Line dirty solvent piping

Picture 3 – Filling Line dirty solvent piping

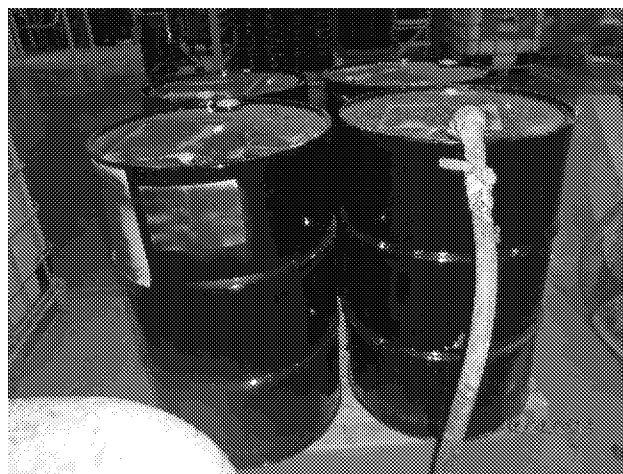
Picture 4 – Filling Line dirty solvent hose and empty drums

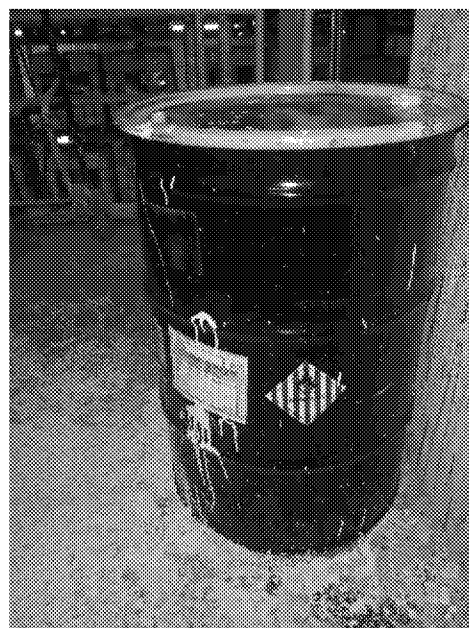
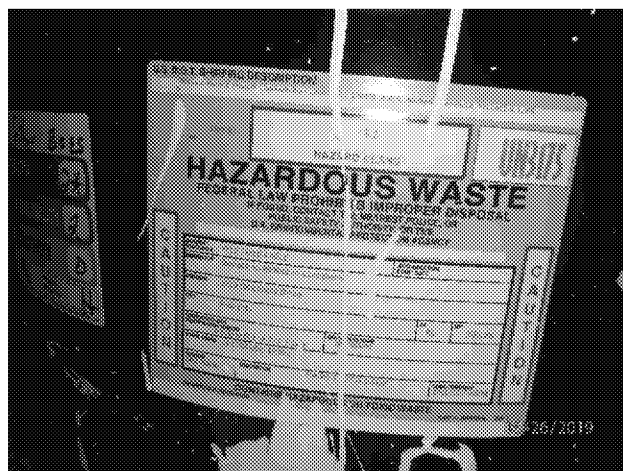
Above the Filling Line were the Fill Tower Tanks. The inspectors observed a 55-gallon satellite accumulation area (SAA) drum of hazardous waste filter bags (Pictures 5-6). The filter bags are generated from the changeover of paint formulations. The drum was closed and labeled. The inspectors also observed a 5-gallon container with a discarded hazardous waste filter bag inside (Pictures 7-8). Mr. Power explained that the 5-gallon containers are used to carry the dirty solvent filter bags to the drum and prevents releases to the area. However, the container was not labeled or closed.

Picture 5 – Filling Line HW filter bag SAA

Picture 6 – Filling Line HW filter bag SAA label

Pursuant to ADEM Admin. Code r. 335-14-3-.01(5)(a)4 [40 C.F.R. § 262.15(a)(4)], which is a condition of the SAA Permit Exemption, a generator is required to keep containers of hazardous waste closed at all times during accumulation, except when adding, removing, or consolidating waste; or when temporary venting of a container is necessary for the proper operation of equipment, or to prevent dangerous situations, such as build-up of extreme pressure.

Pursuant to ADEM Admin. Code r. 335-14-3-.01(5)(a)5 [40 C.F.R. § 262.15(a)(5)], which is a condition of the SAA Permit Exemption, a generator is required to mark or label its containers (i) with the words “Hazardous Waste” and (ii) with an indication of the hazards of the contents.

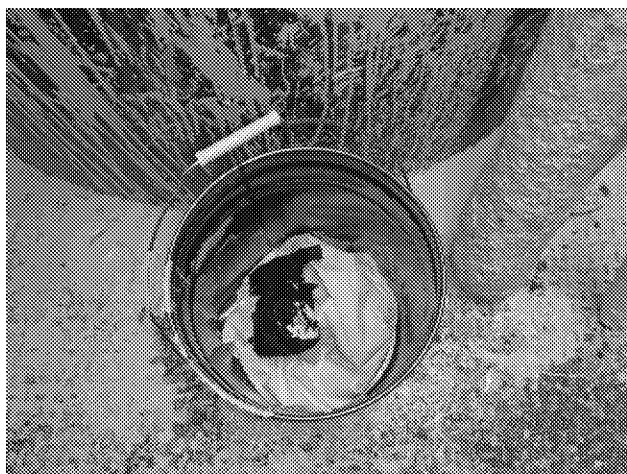
Picture 7 – Filling Line HW filter bag

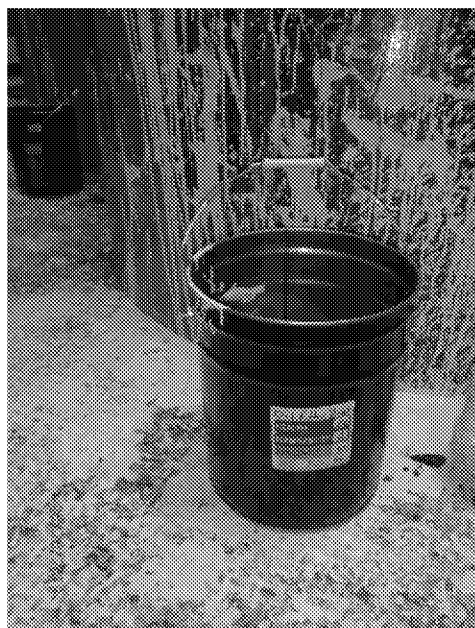
Picture 8 – Filling Line HW filter bag

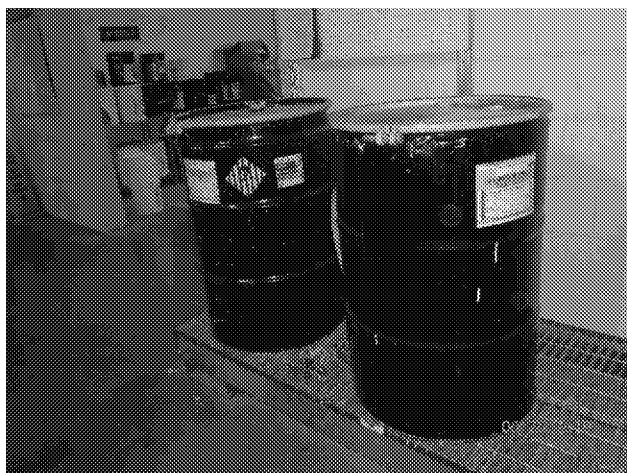
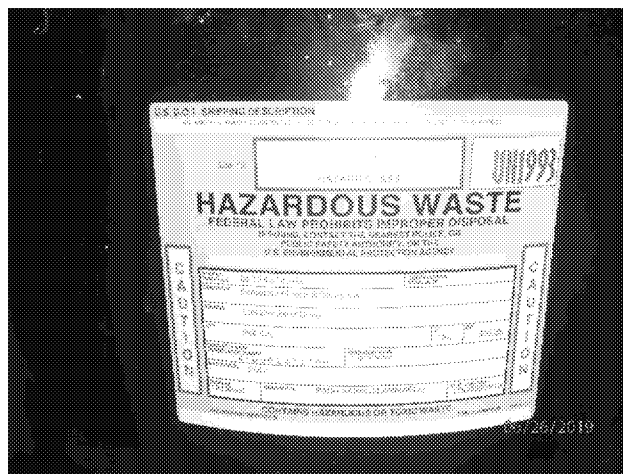
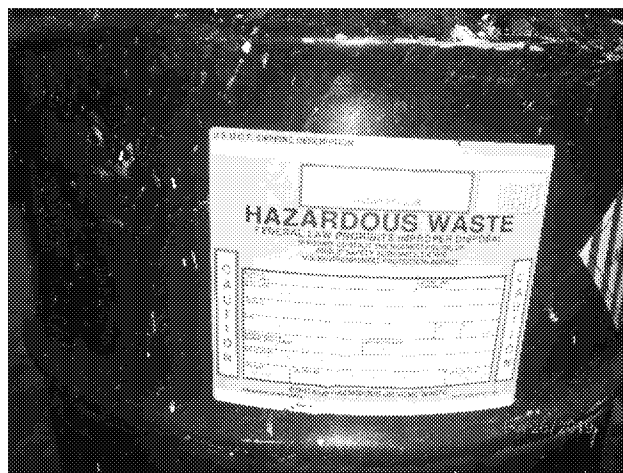
The inspectors observed the Small Batch Process, a smaller version of the main production area, that specializes in specific customer needs. The SAA contained a 55-gallon hazardous waste drum of paint filter bags and a 55-gallon hazardous waste drum of paint skins (Pictures 9-11). The drums were closed and labeled.

Picture 10 – Small Batch Process SAA

Picture 11 – Small Batch Process SAA

Picture 9 – Small Batch Process SAA

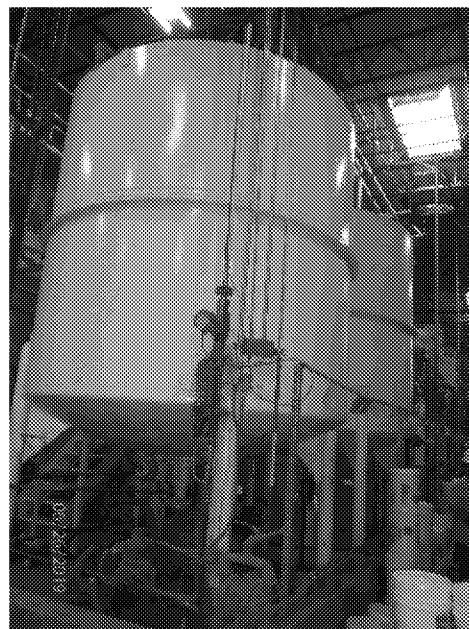
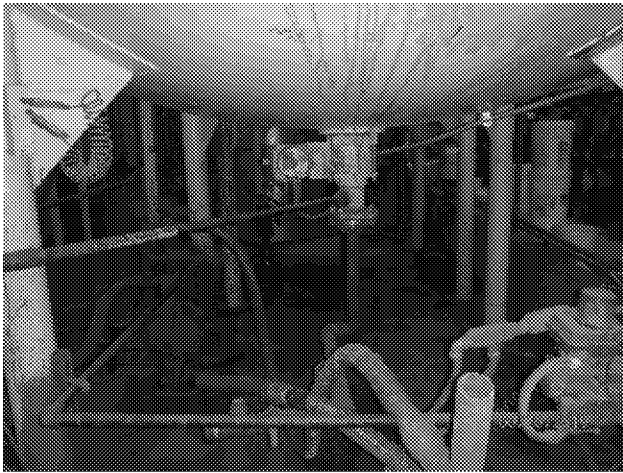
The main warehouse has final product stored in the center aisle and raw materials on the side aisles. This warehouse also houses the solvent tanks and the solvent still. The solvent recovery dirty tank, SRD1 was disconnected from all piping receiving dirty solvent (Pictures 12-16). During the December 18, 2018, RCRA inspection by ADEM, the inspector, Mr. Corey Holmes, observed that the tank and its auxiliary connections were not tagged or monitored for leak detection, daily inspections were not conducted on the tank, the tank was not labeled as hazardous waste and the tank did not have an integrity test conducted by a professional engineer.

Picture 12 – Warehouse Solvent Recovery Dirty tank

Picture 13 – Warehouse Solvent Recovery Dirty tank

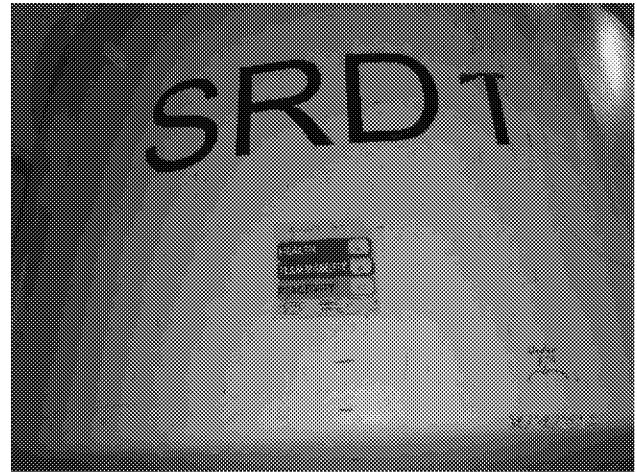
Picture 16 – Warehouse Solvent Recovery Dirty tank label

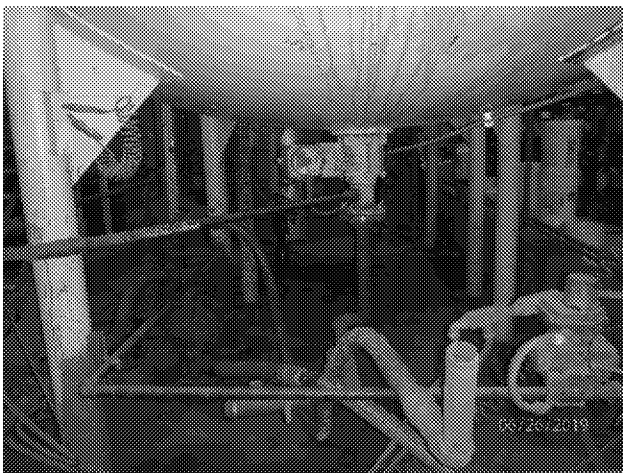
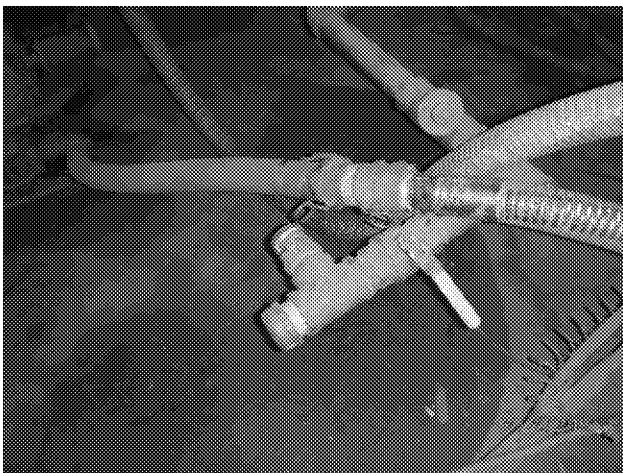
Picture 14 – Warehouse Solvent Recovery Dirty tank piping

Picture 15 – Warehouse Solvent Recovery Dirty tank piping

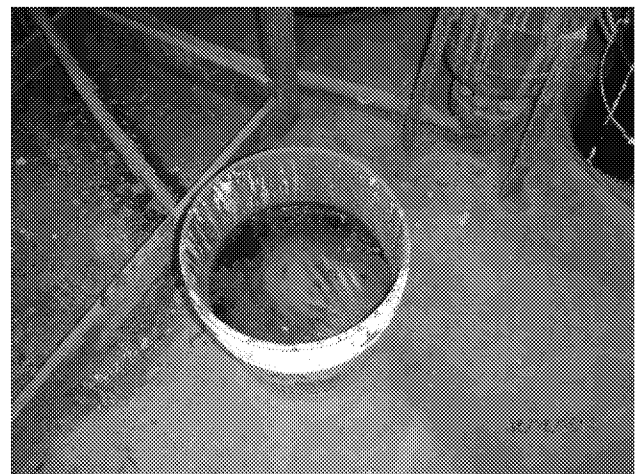
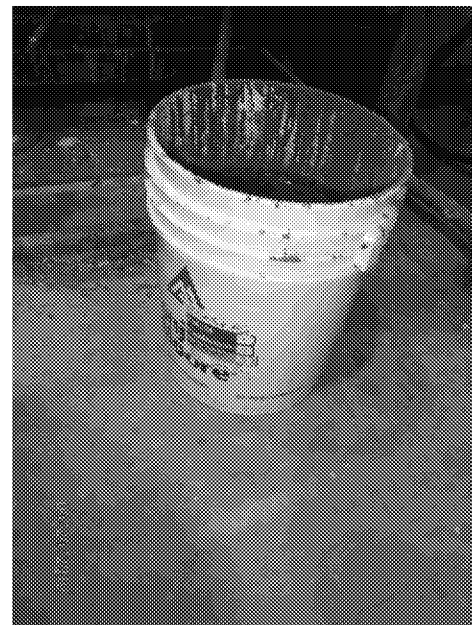
At the time of the inspection, the inspectors observed two 5-gallon containers of unidentified contents. The containers were not closed or labeled. Mr. Power and Mr. Breckenridge were not aware of the contents.

Picture 17 – Distillation unidentified container 1

Picture 18 – Distillation unidentified container 1

Pursuant to ADEM Admin. Code r. 335-14-3-.01(2) [40 C.F.R. § 262.11], a person who generates a solid waste, as defined in ADEM Admin. Code r. 335-14-2-.01(2) [40 C.F.R. § 261.2], must make an accurate determination as to whether that waste is a hazardous waste in order to ensure wastes are properly managed according to applicable RCRA regulations.

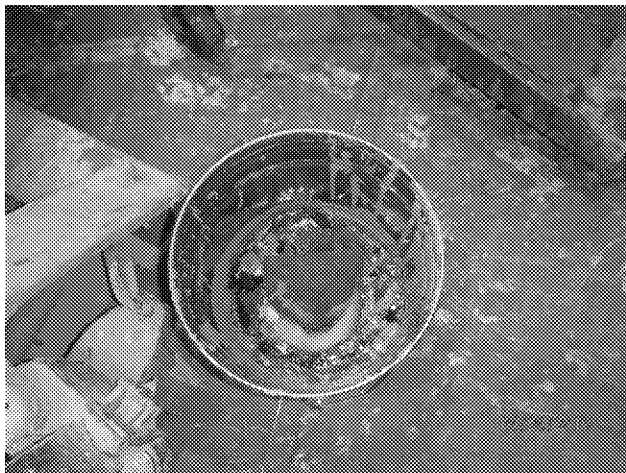
Picture 19 – Distillation unidentified container 2

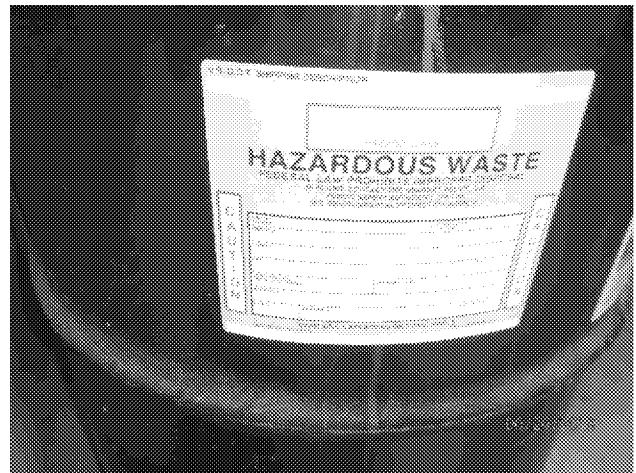
Picture 22 – Low Flash Lab SAA drum label

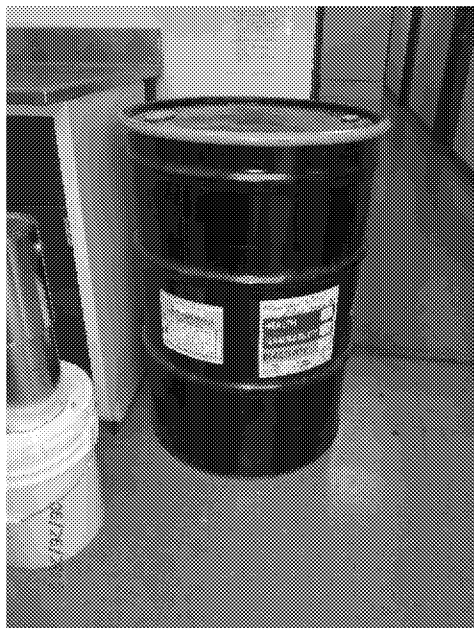
The Low Flash Lab is a separate room that provides quality control for the solvent based paints. There were multiple SAA in the Low Flash Lab. The inspectors observed a black 55-gallon SAA of hazardous waste alkyd clean up material, a white 5-gallon container of latex waste, two silver one-gallon containers of latex waste, a black 5-gallon container of lab waste that did not have hazardous waste label (Pictures 20-22), a cart with spent aerosol cans to be punctured that were not labeled (Picture 23), and a red fire can of xylene used for cleaning paint brushes (Picture 24).

Picture 20 – Low Flash Lab SAA drum

Pursuant to ADEM Admin. Code r. 335-14-3-.01(5)(a)5 [40 C.F.R. § 262.15(a)(5)], which is a condition of the SAA Permit Exemption, a generator is required to mark or label its containers (i) with the words “Hazardous Waste” and (ii) with an indication of the hazards of the contents.

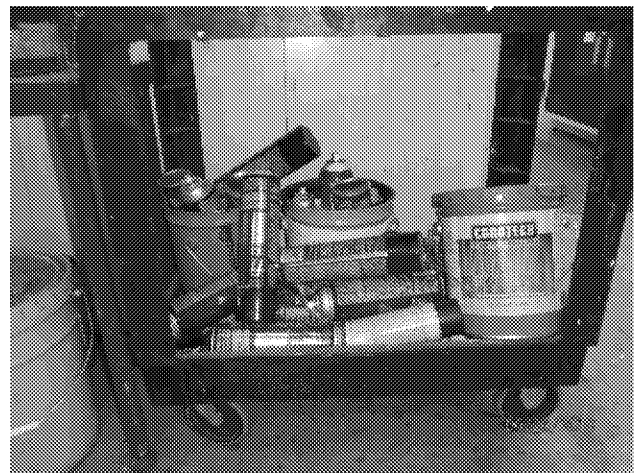
Picture 23 – Low Flash Lab spent aerosol cans

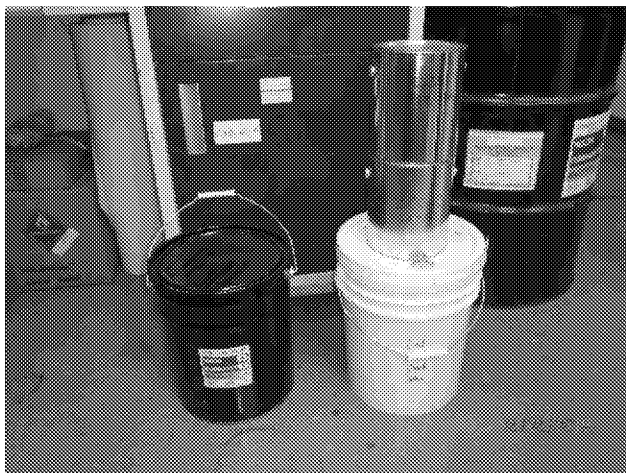
Picture 21 – Low Flash Lab SAA, non-HW containers and unidentified container

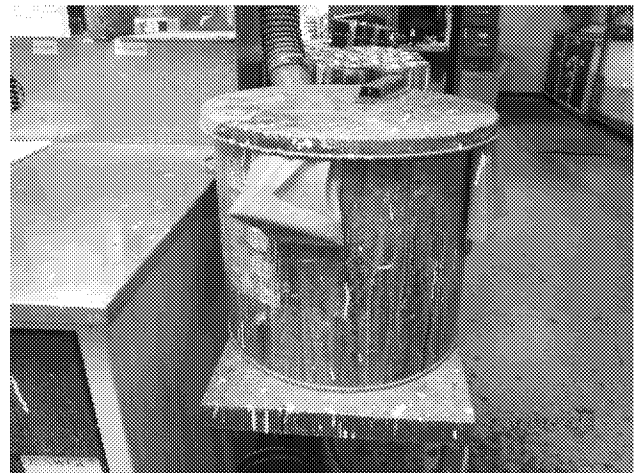
Picture 24 – Low Flash Lab xylene cleaning container

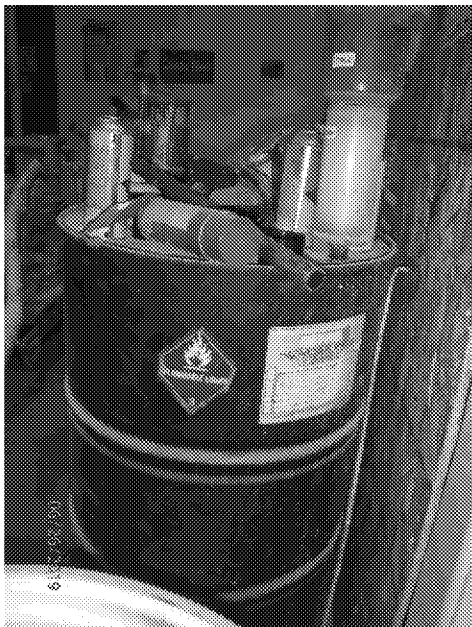
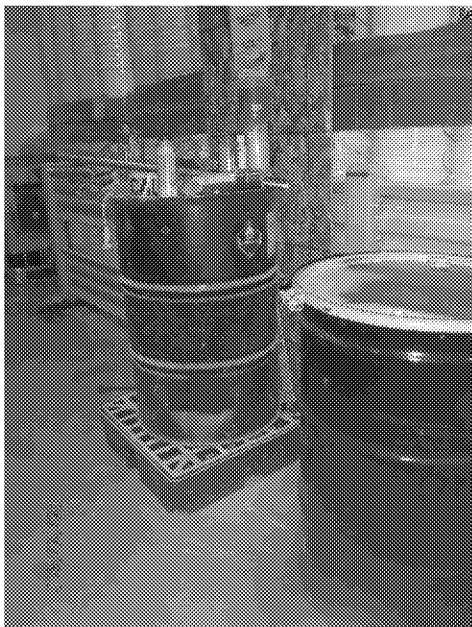
The 55-gallon SAA drum of spent aerosol residue was in the Caustic Wash area (Pictures 25-26). The drum had an aerosol can puncture system attached to the bung and aerosol cans and debris stored on top. The drum was observed to be closed and labeled.

Picture 25 – Caustic Wash aerosol can puncture system and drum

Picture 26 – Caustic Wash aerosol can puncture system and drum

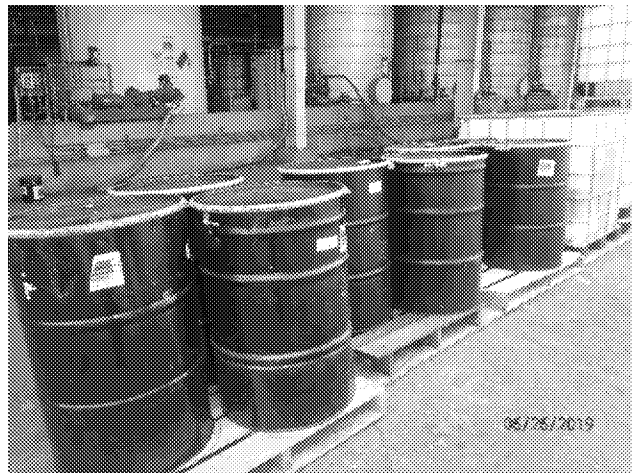
At the time of the inspection, six 55-gallon used oil drums and two 55-gallon drums of sprinkler water were staged near the tank farm waiting for pickup (Picture 27). The drums had been staged since June 25, 2019, but the transporter had not yet arrived to pump the oil out of the drums. The used oil drums are normally stored in the non-hazardous waste area of the CAA. The used oil was generated from the air compressor.

Picture 27 – Used oil drums staged

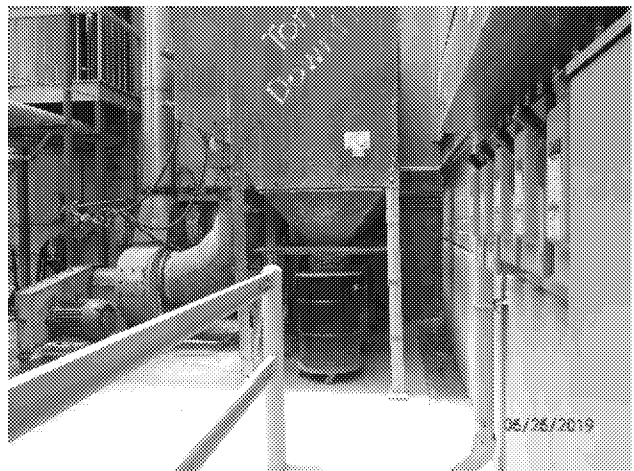
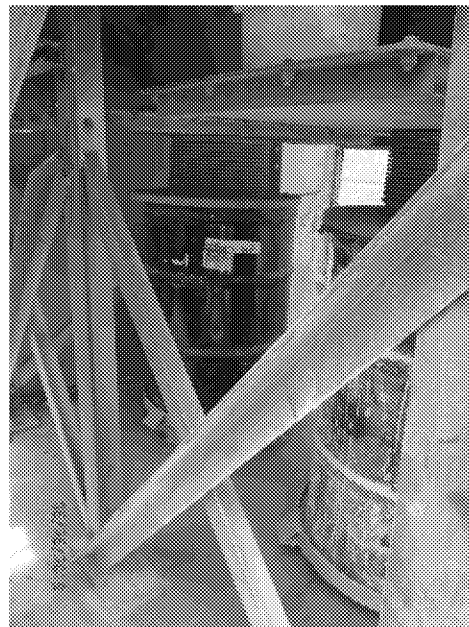
During the tour, the inspectors observed an outside baghouse. Mr. Power explained that the facility has five baghouse hoppers for pigment dust. The baghouse the inspectors observed had three hoppers with 55-gallon drums underneath (Pictures 28-29). The pigment dust is disposed of as non-hazardous waste.

Picture 28 – Pigment Dust Baghouse and drums

Picture 29 – Pigment Dust Baghouse drums
